# Manhole Inspection Summary

Manhole # S33A\_\_045MH

**Location** Address: **515 CENTRE ST** Cross Street: **CATHEDRAL ST**

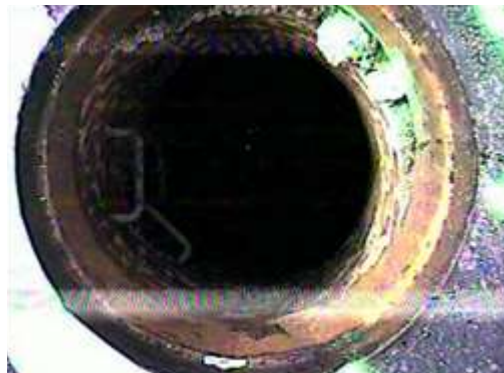
Top View

**Frame** Offset: **2** (in.) Condition: ☒ Sound ☐ Cracked ☐ Leaks

FRAME OFFSET

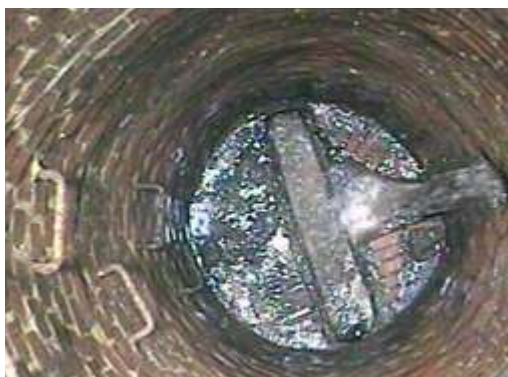
Top View

FRAME OFFSET

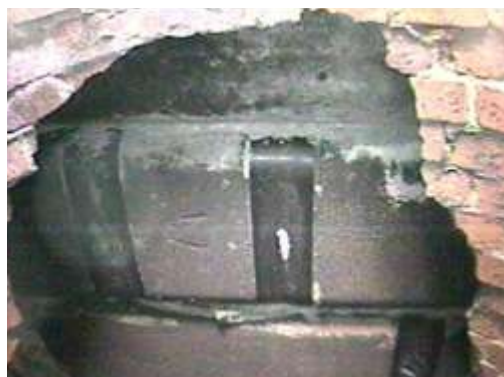
Hole in barrel

Condition: ☐ Sound ☐ Cracked ☐ Root Intrusion ☐ Loose Brick ☒ **Deteriorated**

UNKNOWN - BARREL

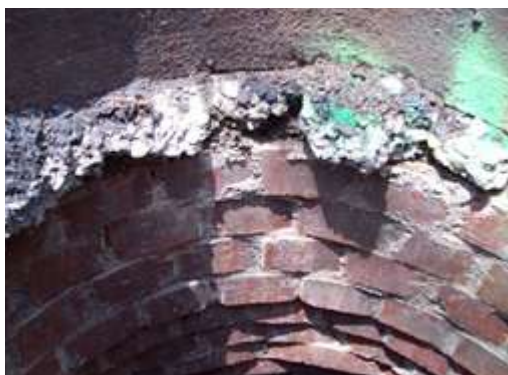
Defect 1

Condition: ☐ Sound ☒ **Cracked** ☐ Root Intrusion ☐ Loose Brick ☐ Deteriorated

CHIMNEY FRAME ADJUSTMENT  
CRACKED

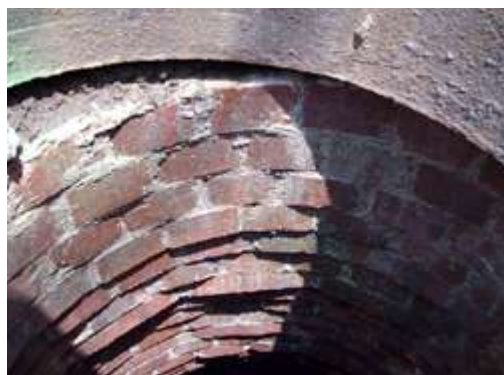
Defect 2

BARREL DETERIORATED

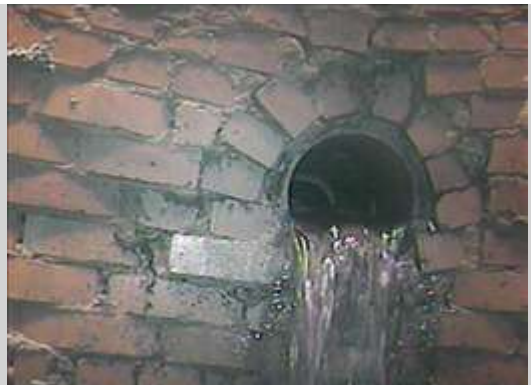
3 O'Clock Inflow

**Drop Too Heavy - Cannot Take the Picture for Pipe In At 3 O'clock**

8 in. Circular Gravity Sewer  
Pipe In @ 3 O'Clock

Drop: **Inside** **Direct**  
Angled: Reading: (ft.)  
Inv Depth: **16.65** (ft.)  
Drop Condition: **Clogged**

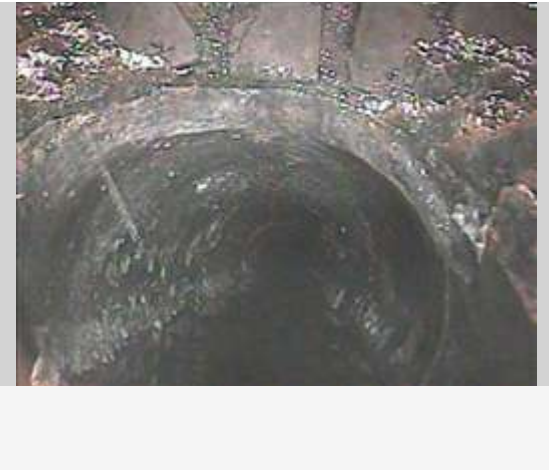
6 O'Clock Inflow

12 in. Circular Gravity Sewer  
Pipe In @ 6 O'Clock

Deposits: ☐ None ☐ Mud ☐ Sludge ☐ Debris ☒ **Grease**

Silt Depth: **2** (in.) Deposits Extent: **Light**
